Morecambe Phase VI coastal defence development

Mitigation works - Technical Note 2

1. End of Mitigation Habitat Creation Work

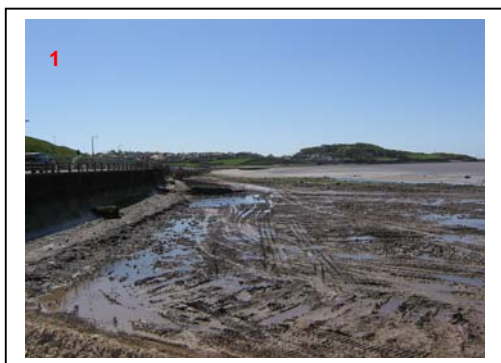
- (2) **Skear resource:** - By the end of the work all the available skear resource beneath the footprint of the Sunnyslopes Breakwater had been relocated into the mitigation area. This included the area of barren and loose cobble deposits within the top 10m of the shoreline (i.e. adjacent to the sea wall and above the neap tide high water mark). This loose cobble area had originally been excluded because it did not have precisely the same clay/cobble matrix as the main skear. However, because these cobbles can still be used to provide an appropriate skear substratum they were relocated when the supply of materials from all other parts of the natural skear had been exhausted. The excavated areas on the south and north sides of the proposed breakwater footprint are shown in Photos 1 and 2 respectively.

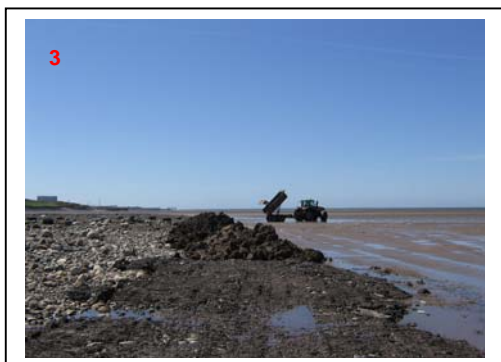
- (3) **Final Deposits:** As the skear resource was exhausted by the final day, a large proportion of the last materials being relocated was clay (around 70-80%) rather than pebble/cobble. Photo 3 shows these last deposits being laid and the differences between them and the main body of the skear (which is cobble-dominated) is evident in this picture. Due to the very high proportion of clay, these final materials were no longer suitable for cobble skear creation.

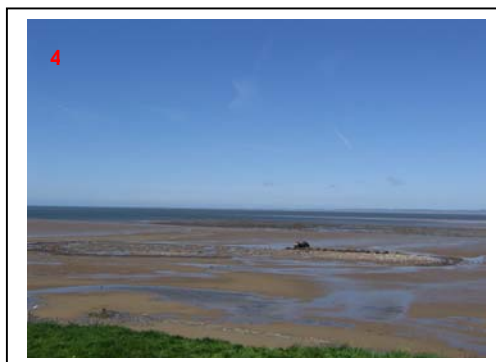
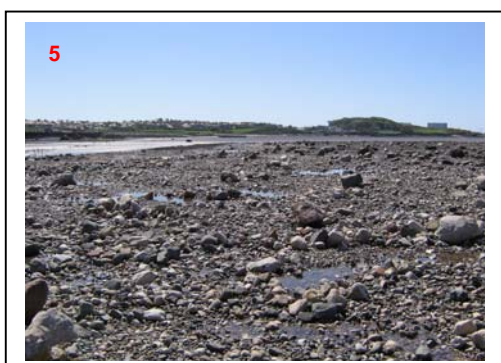
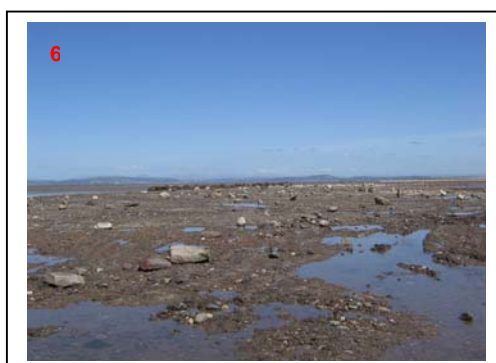
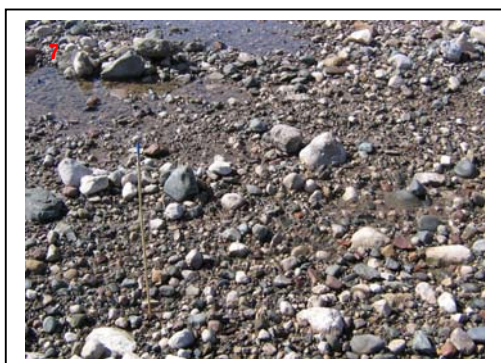
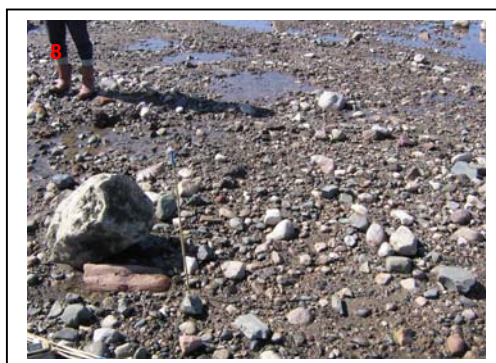
- (5) **Skear Appearance:** - Due to the measures that were taken when re-laying the skear materials (see Note 1) the new skear habitat shows encouraging similarities with other natural skear areas in the vicinity. It is largely dominated by coarse rocky materials, it has a firm clay matrix and has large boulders scattered across its surface that give the appearance of natural glacially deposited 'eractics'. Crucially, ponds have formed in the tracks left by the digger that laid the materials and it is hoped that these will help to enhance species settlement and epifaunal abundance in the new habitat. The habitat as viewed from distance is shown in Photo 4. Across the new skear there is a change in the habitat types with the northern third of the area being a cobble and pebble dominated substratum while the southern two thirds are a mixture of firm exposed clay and fine sand (covering between 10 and 50% of the surface) with pebble and cobbles covering the remainder of the area. Large boulders were scattered relatively evenly across all parts of the feature.

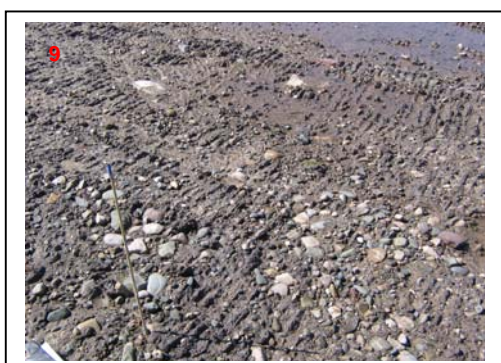
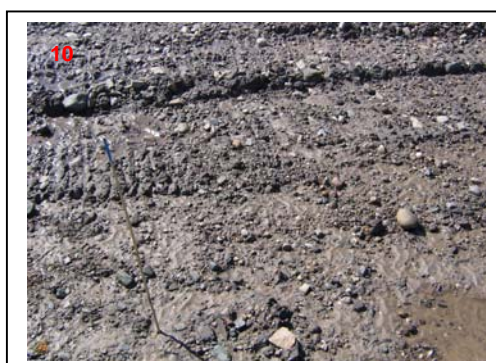
- (6) **Establishing Sampling Location:** - As required by the proposed monitoring programme, 6 sampling points (labelled A to F) were set up and accurately positioned across the skear area. Photographs of the substratum were taken at each site to provide a visual baseline record. Two of the sites were located within the cobble/pebble-dominated area to the north (see Photos 7 and 8 show Sites 'A' and 'B') and four sites were positioned in the mixed substratum to the south of the area (see Photos 9 and 10 show Sites 'E' and 'F').
